RESTORE EXTERIOR MASONRY
REPOINT BRICK, REPAIR STUCCO, REPAINT

REPLACE HISTORIC WINDOWS
TRIPLE GLAZED, THERMALLY BROKEN,
MATCHING HISTORIC PROFILES, SIGHT LINES,
INSETS, AND MATERIALITY

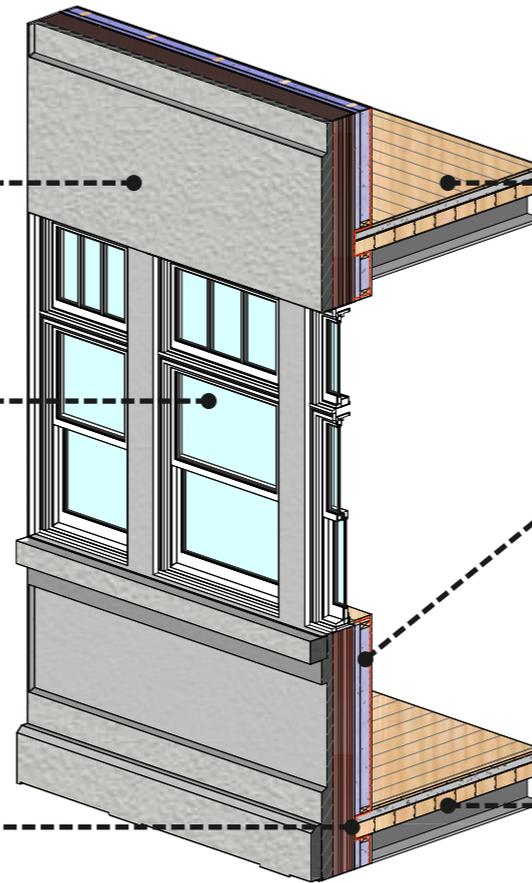
CHALLENGE: ONGOING INVESTIGATION
REDUCTION OR ELIMINATION OF THERMAL
BRIDGING INHERENT IN EXISTING
CONSTRUCTION TYPE, WHERE STEEL
STRUCTURE BEARS ON MASONRY WALLS

NEW WOOD FLOORING
SUSTAINABLE AND DURABLE MATERIAL
PALATE

**NEW HIGH PERFORMANCE ENVELOPE
UPGRADES**
LIQUID-APPLIED AIR BARRIER, CONTINUOUS
INSULATION WITH SMART VAPOR CONTROL
MEMBRANE, WOOD STUD FURRING WITH
BATT INSULATION TO ACCOMMODATE
UTILITIES, FINISHED GWB SURFACE

**RETAIN EXISTING WOOD DECKING AND
STEEL STRUCTURE**
MAINTAIN EMBODIED CARBON WITHIN
FUNCTIONAL MATERIALS, EXPOSE HISTORIC
CHARACTER
